**ENROLLMENT FOR ELECTRIC SERVICE
LETTER OF AUTHORIZATION**

WHEREAS, the courthouse is in need of critical repairs;

Scope of Protection Documentation

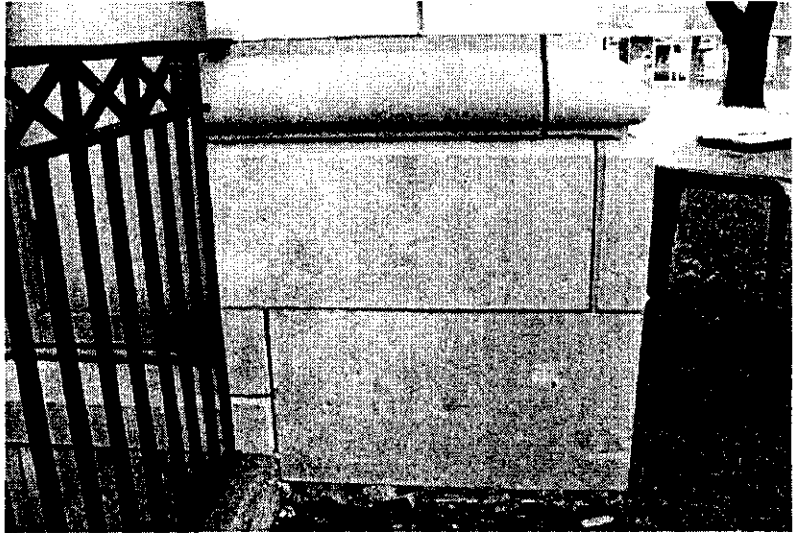
*Displacement of the water table near the south entry.
(Jaster-Quintanilla)*

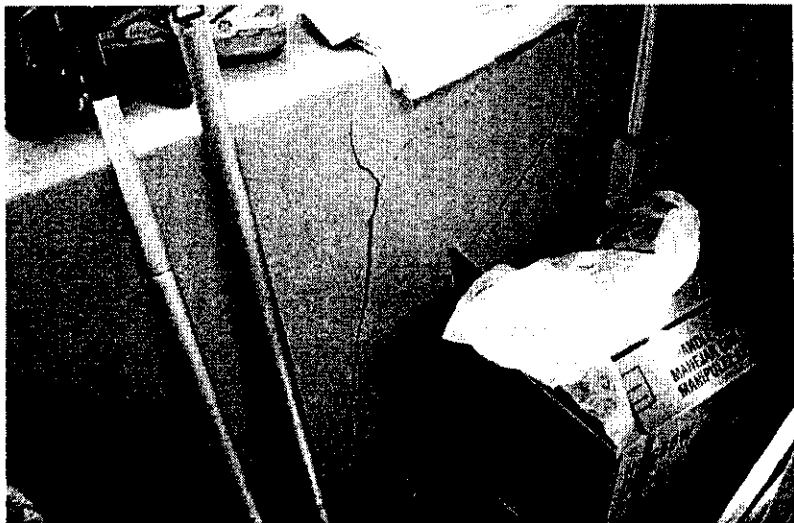
*Cracking carries through the wall to the interior plaster.
(Jaster-Quintanilla)*

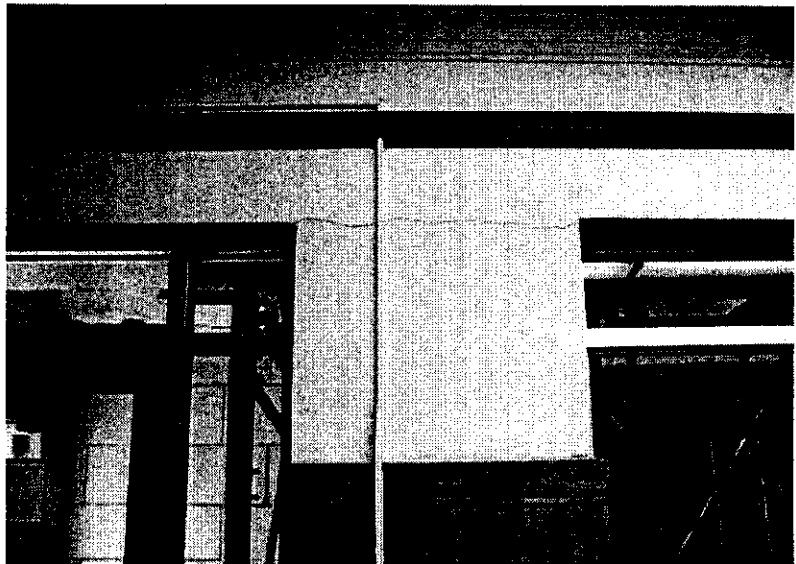
Typical cracking of plaster at the corner of windows. (Jaster-Quintanilla)

Walls which have cracked shall be repointed with mortar to seal the cracks and prevent further moisture penetration into the wall. The mortar shall have hardness and strength comparable to the existing mortar. Ornamental features shall be sealed to prevent moisture intrusion.

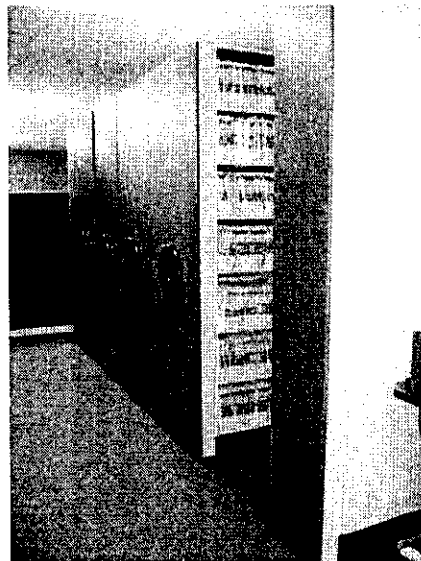
ment has a higher or lower maximum load capacity. It is not known if the original structure was reinforced at these locations to accommodate the increase in the imposed live loads.

*High density storage units on upper floors may require reinforcement of the structural system.
(Jaster-Quintanilla)*

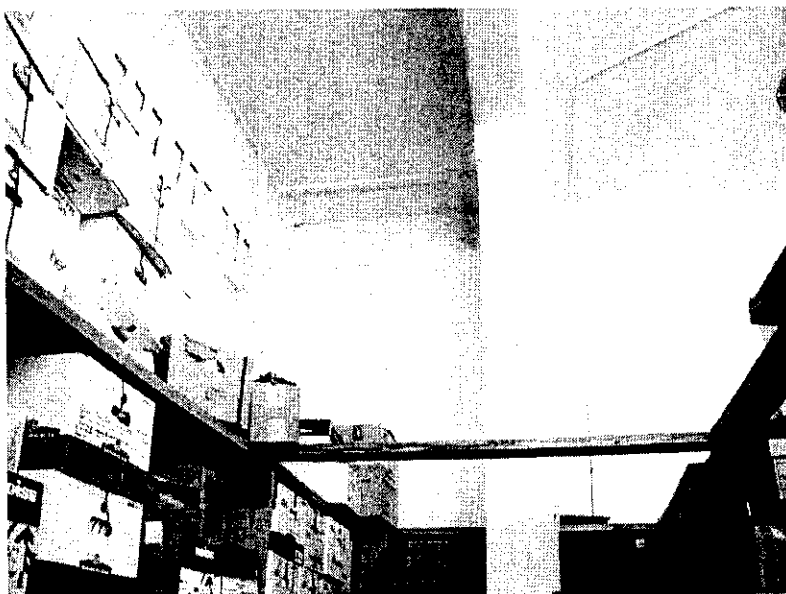
*A portion of the steel cell block has been removed to accommodate storage.
(Jaster-Quintanilla)*

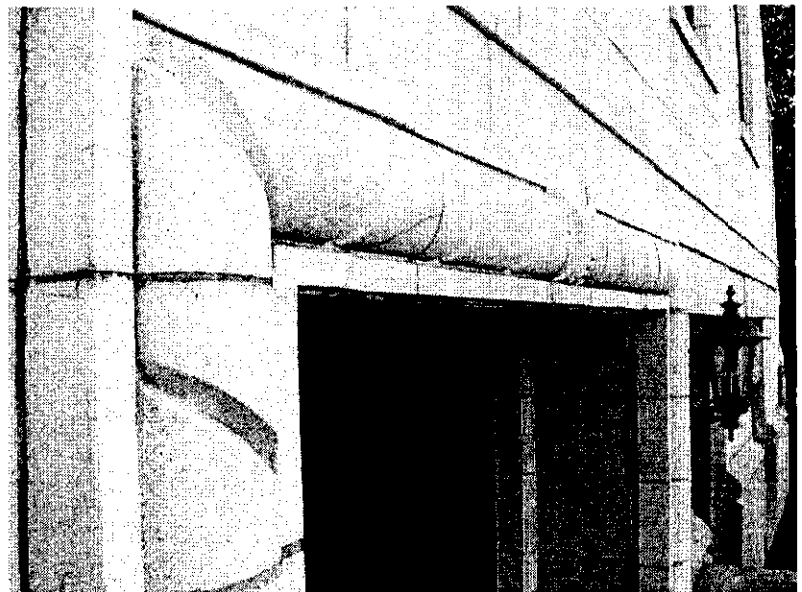
*While there is some rusting of the
lintels, it does not appear to be
affecting the masonry.
(Jaster-Quintanilla)*

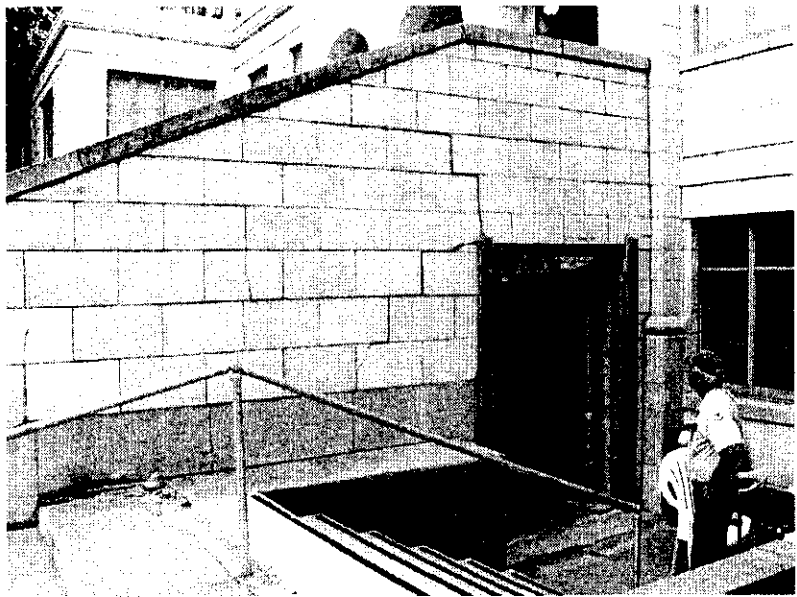
Severe cracking and failure below the landing of the south stair.. (Jaster-Quintanilla)

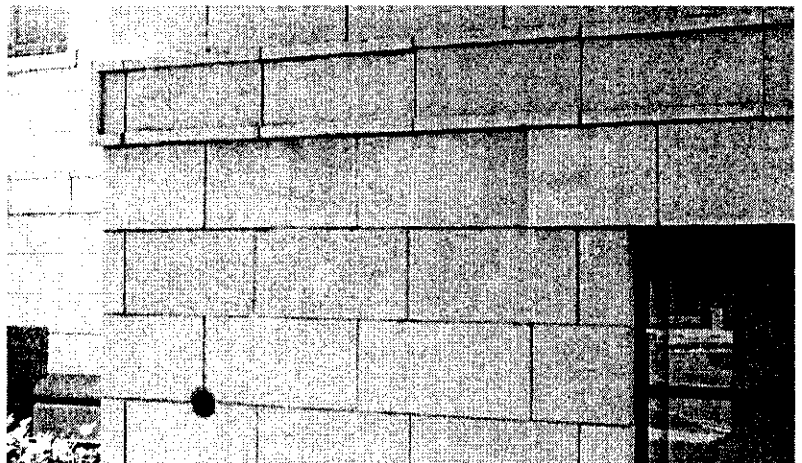
There is some cracking trough units due to structural movement. This is particularly noticeable on the in-

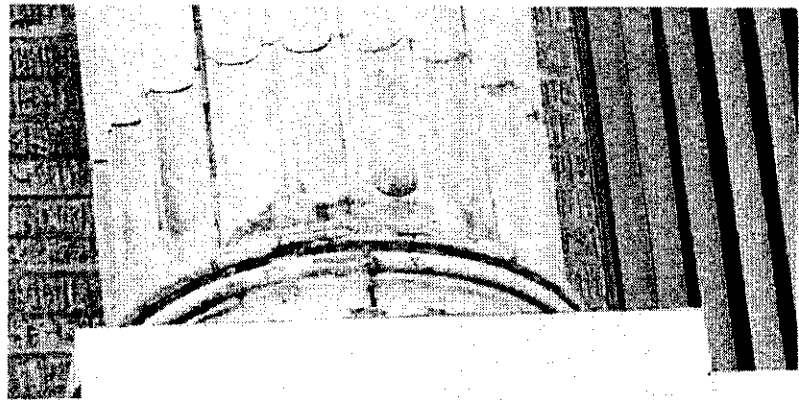
Deep staining of much of the terra cotta will require some experimentation to determine the most effective cleaning methods. (ARCHITEXAS)

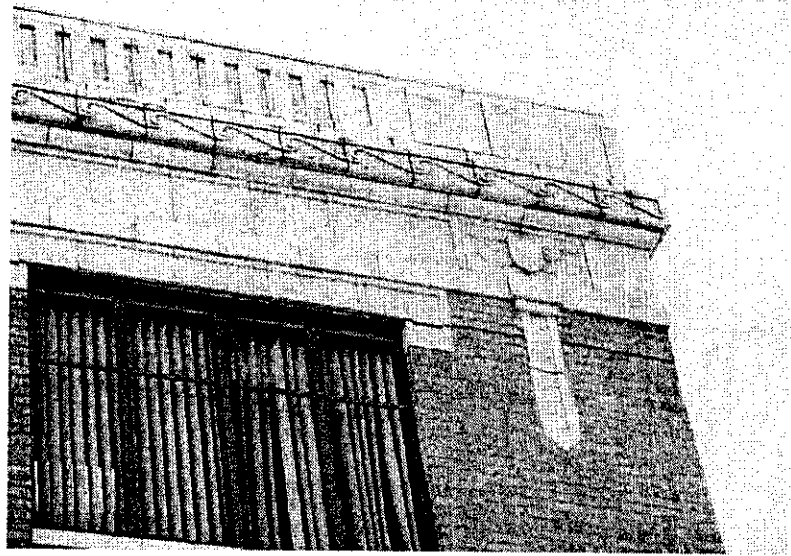
Existing sealants are beginning to fail and require replacement. Brick is in good condition. (ARCHITEXAS)

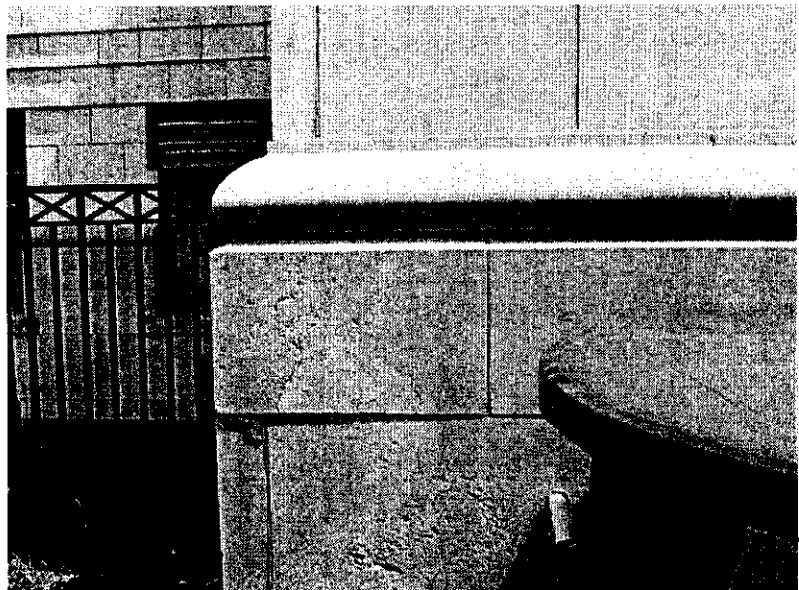
Underpinning of the foundation is necessary on the north and south sides of the building to reduce movement issues. (ARCHITEXAS)

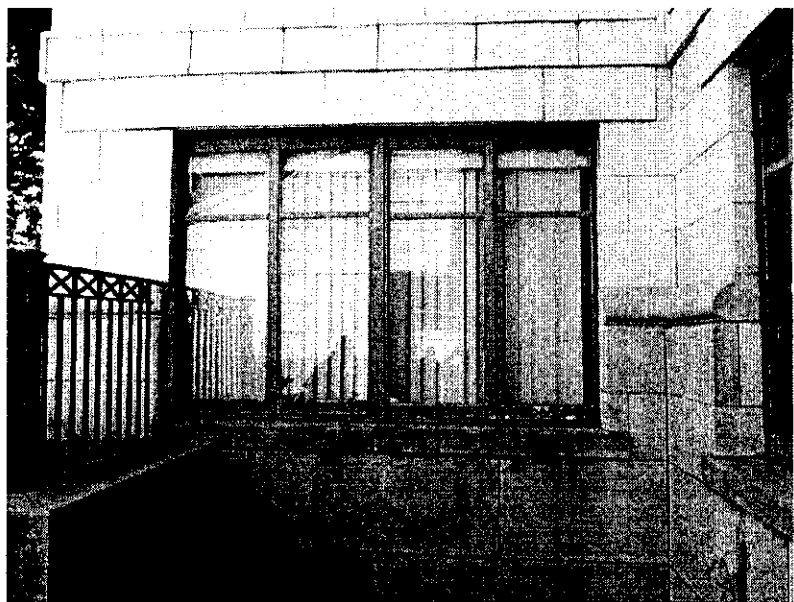
Foundation issues on the north and south sides of the building are evident at windows near the building entries. (ARCHITEXAS)

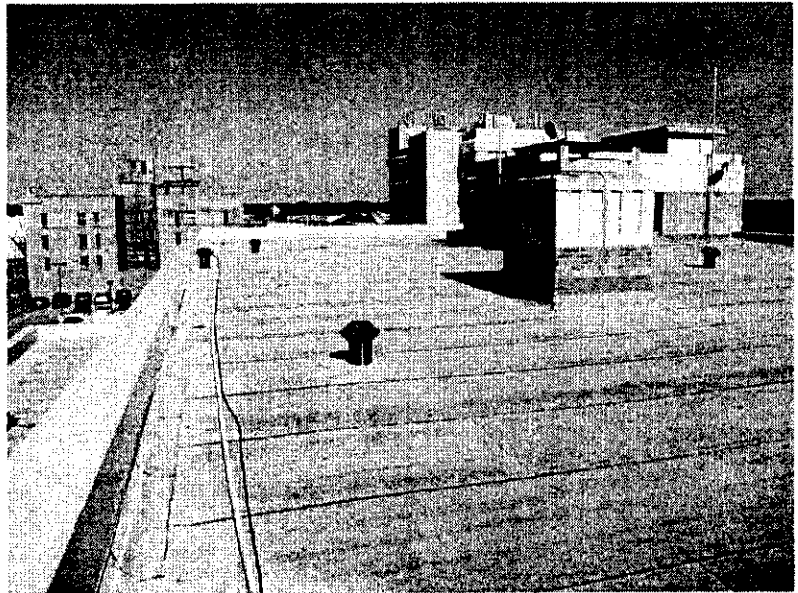
The roof will need replacement within the next to years. (ARCHITEXAS)

Assume that in the next 10 years it will be necessary to replace the entire roofing system and related flashings. Use either built-up or modified bitumen type roof. Construct base flashings with granu-

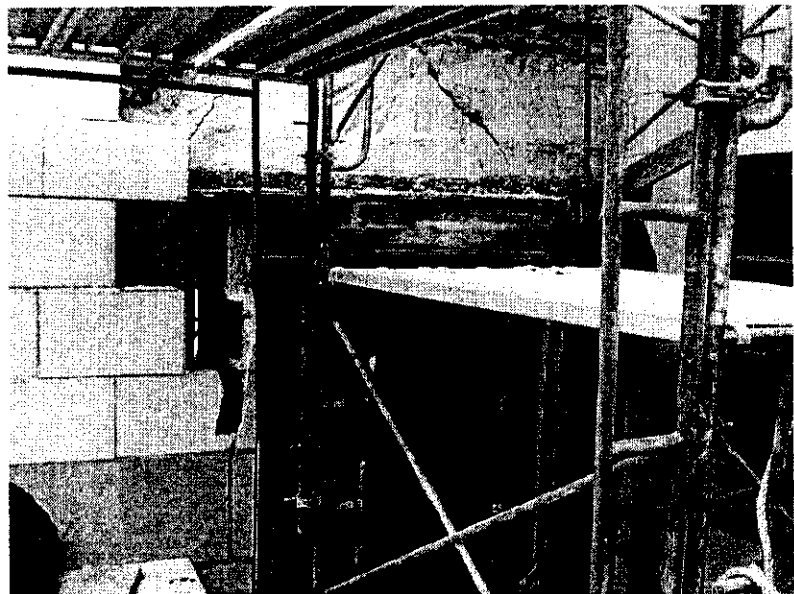
Investigative work at the south stair has revealed severe deterioration of the underlying concrete and steel. Shoring has been installed and the entrance sealed to prevent failure and injury. (ARCHITEXAS)

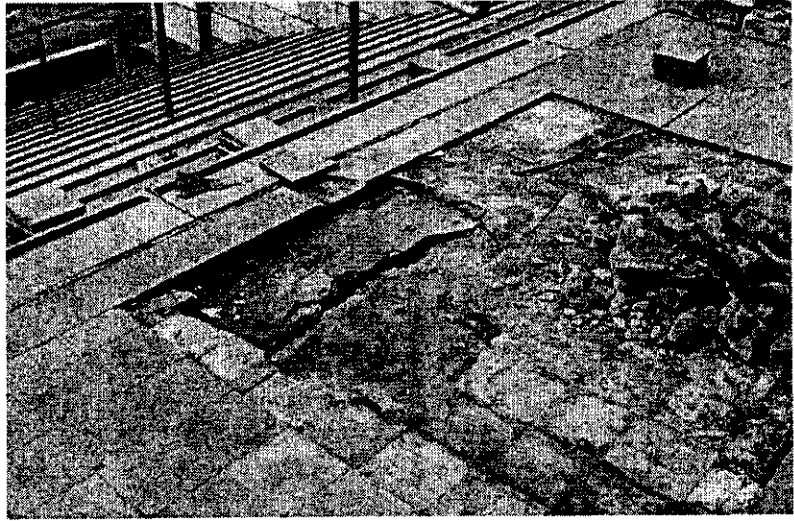
Failure of the previously-installed epoxy glaze at the south stair. (ARCHITEXAS)

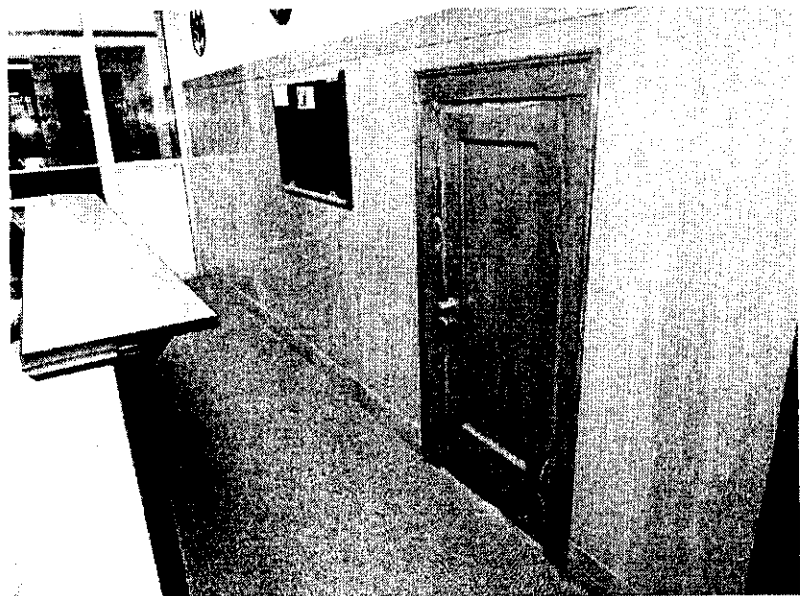
Marble wainscoting In the converted corridor at the Auditor's offices. The small door is a plumbing access hatch and is poorly sealed.(Architexas)

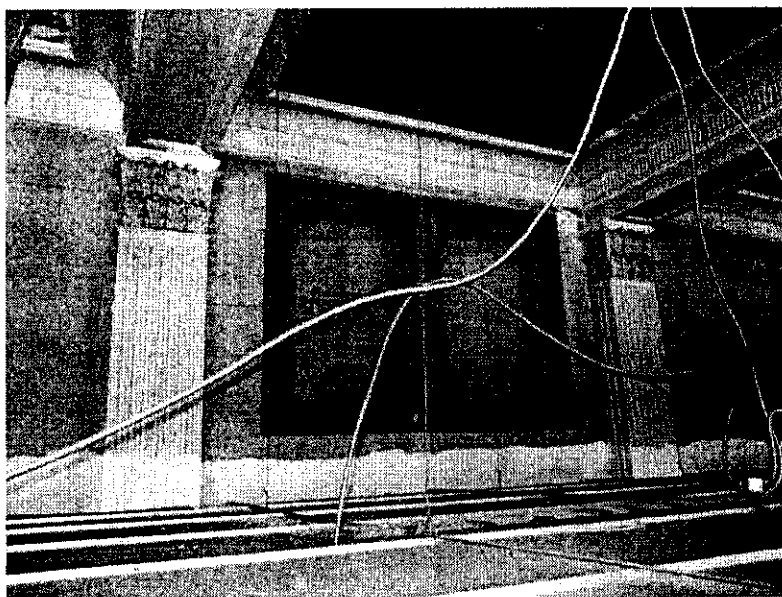
Original painted ornamentation in the building was quite dramatic and is worthy of restoration. A paint analysis is recommended. (Architexas)

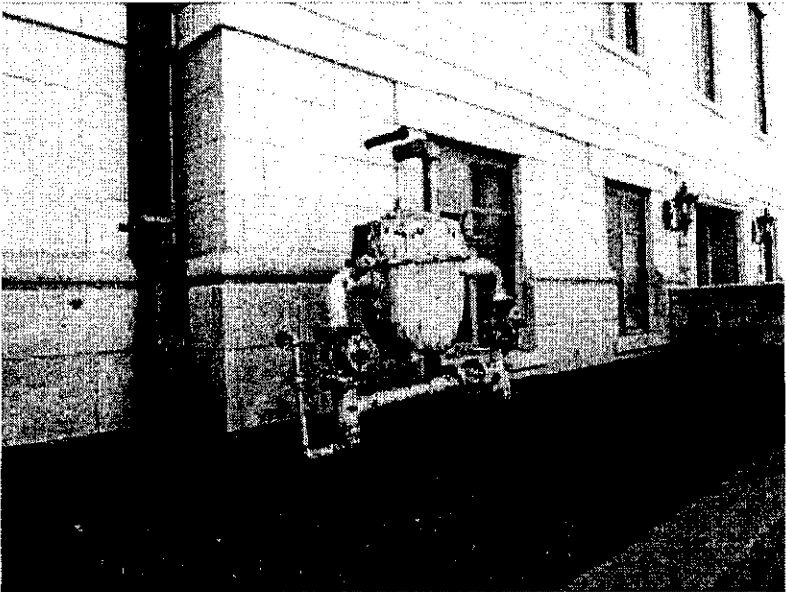
The gas service is no longer needed and can be eliminated unless the county chooses to install a gas-fired boiler.. (Johnson Consulting Engineers)

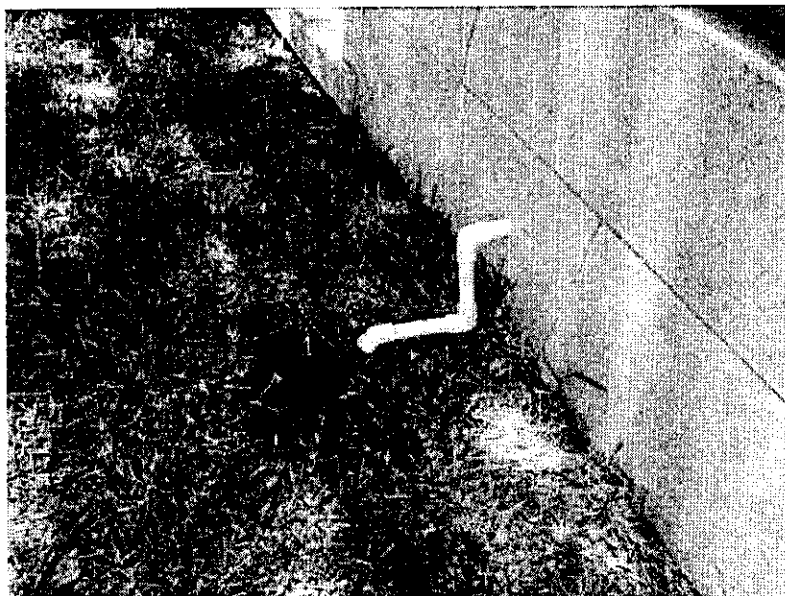
Condensate drain at ground-level air handler. (Johnson Consulting Engineers)

Instances of condensate drain piping discharging on to grade were observed. This can lead to long term structural problems due to differential swelling of soils.
