**ENROLLMENT FOR ELECTRIC SERVICE
LETTER OF AUTHORIZATION**

WHEREAS, the courthouse is in need of critical repairs;

Scope of Protection Documentation

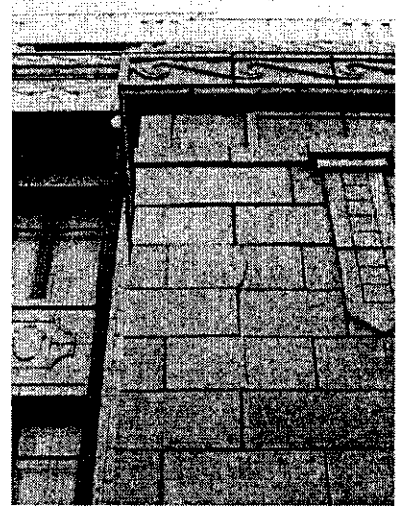
*Displacement of the water table near the south entry.
(Jaster-Quintanilla)*

ern inset the stone veneer “water table” at the base of the wall was observed to be separating from the structure. Cracks were also observed on the interior at this location. These cracks appear to be the result of building foundation movement at the inset corners near the stairs.

Underpin foundation at the inset corner on the south elevation where settlement was observed. Repair cracks in terra cotta veneer.

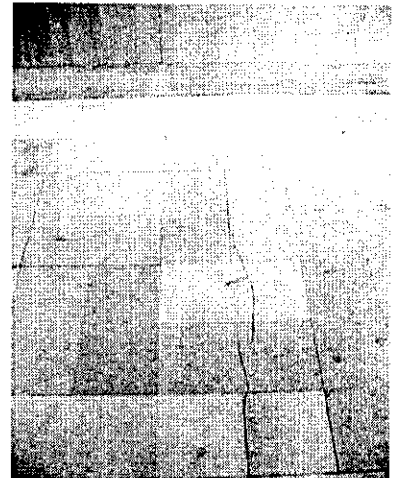
The floors were observed to be uneven in some areas of the ground level. Cracks were observed in the first floor slab-on-grade. The cracks are minor and most likely due to concrete shrinkage.

Cracking of the first floor slab on grade is apparent in the floor tile. (Jaster-Quintanilla)

In addition to recommended underpinning of the foundations, some portions of the basement slab may require demolition and replacement or other remedial action.

In areas with simple cracking due to shrinkage, no repair is needed at this time, but the cracks should be monitored for any change in the future.

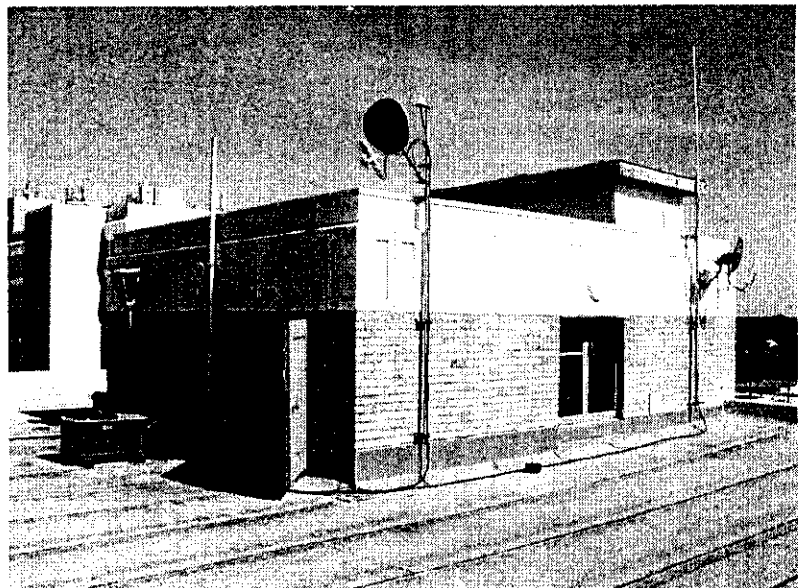
The roof and penthouse with extended elevator over run. (Jaster-Quintanilla)

As part of a comprehensive rehabilitation, expose, inspect and repair framing as necessary. If possible, the penthouse should be returned to its original height.

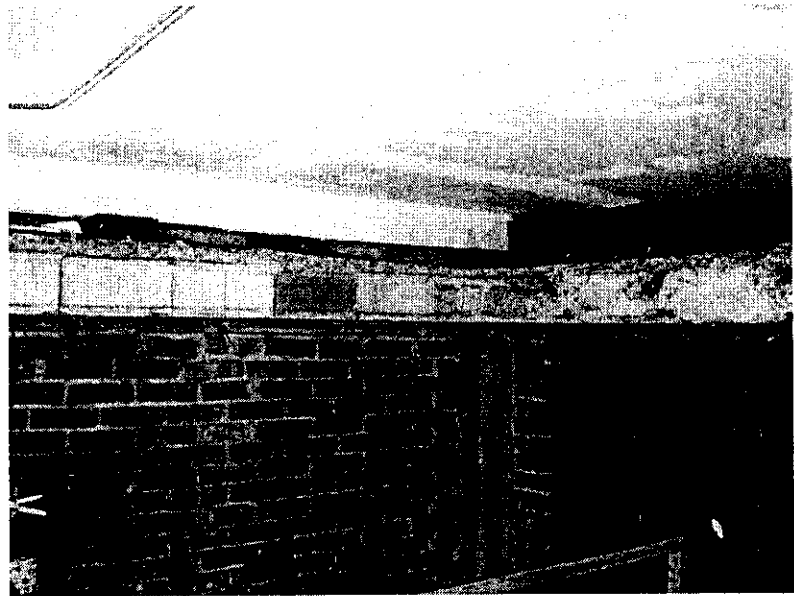
The original penthouse roof was modified to create more over run. (Jaster-Quintanilla)

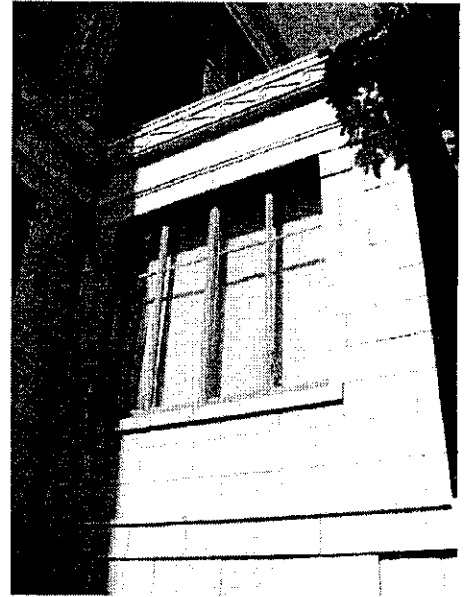
Typical terra cotta cladding at the projecting bays. (Jaster-Quintanilla)

Where terra cotta is beyond repair, remove and replace broken terra cotta units to match existing.

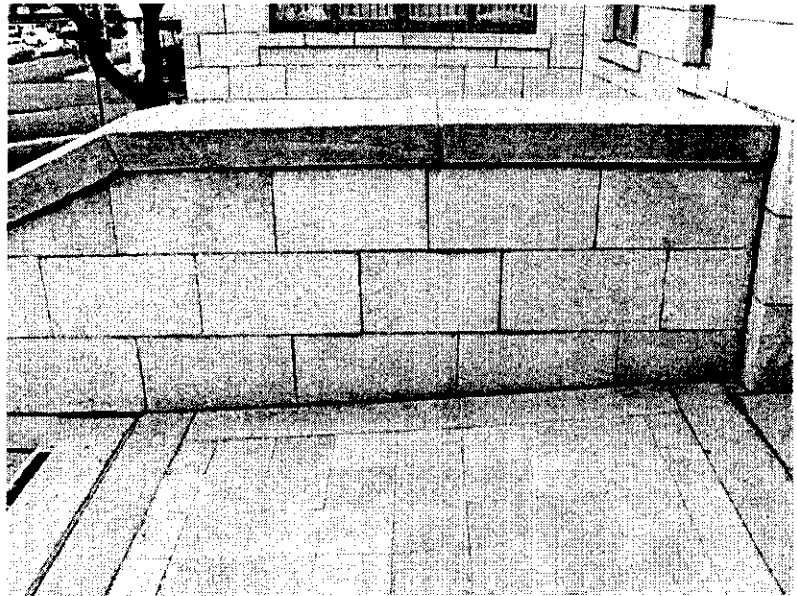
Typical conditions at the monumental stair landings. (Jaster-Quintanilla)

The concrete beam supporting the monumental stair on the south elevation was observed to be spalled and cracked. In addition, the steel angles supporting the terra cotta at this location were observed to be failing. Similar conditions were observed at the monumental stairs on the north elevation, but the deterioration was not as severe. For more detailed information on the monumental stairs, see Structural Review, North and South Exterior Entry Stairs Report by JQ, dated June 18, 2012.

As of the writing of this report, the monumental stairs are unsafe and are the subject of a comprehensive evaluation and repair project. For detailed information on the monumental stairs, see Structural Review, North and South Exterior Entry Stairs Report by JQ, dated June 18, 2012.

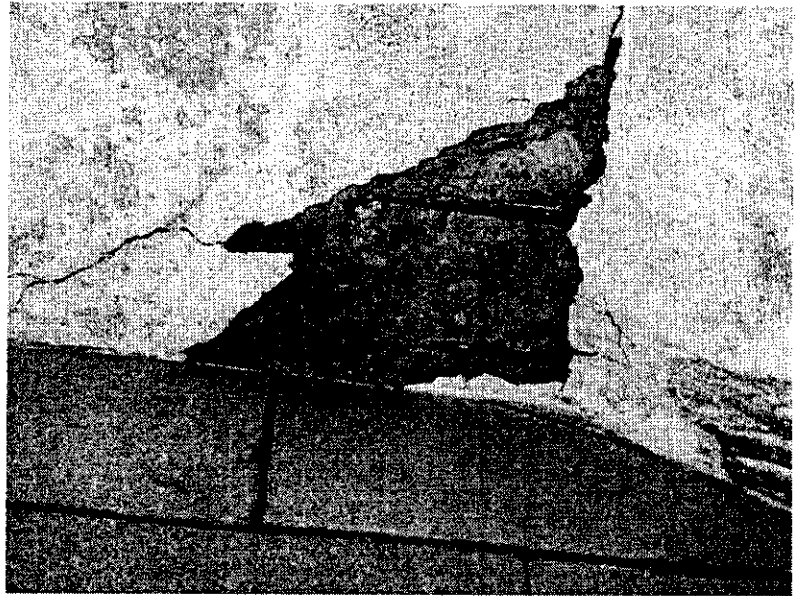
*Exposed reinforcing steel in the soffit of the south stair landing.
(Jaster-Quintanilla)*

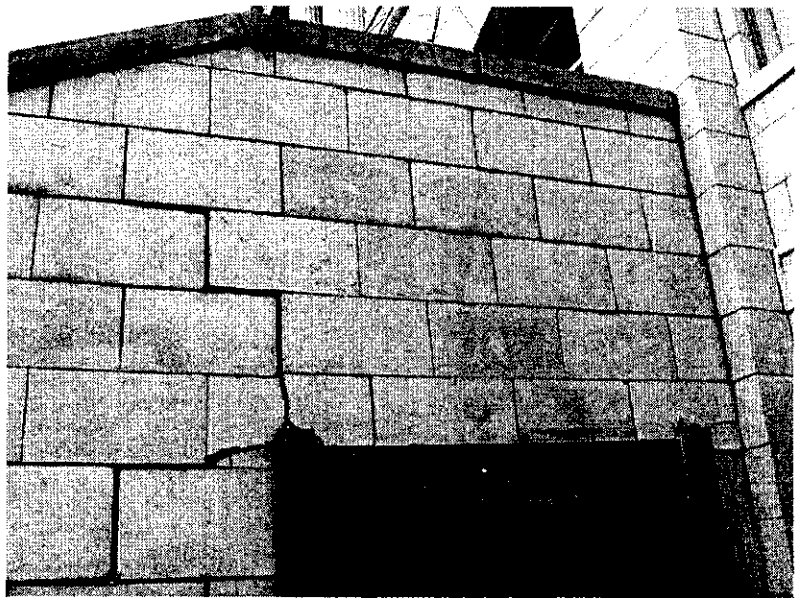
*Another view at the south stair.
(Jaster-Quintanilla)*

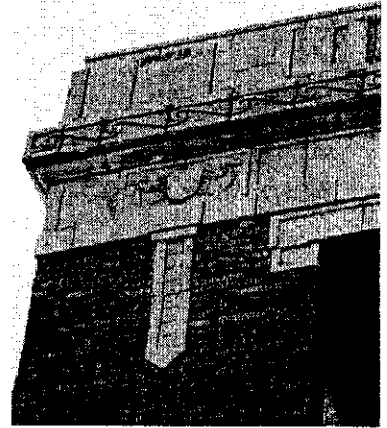
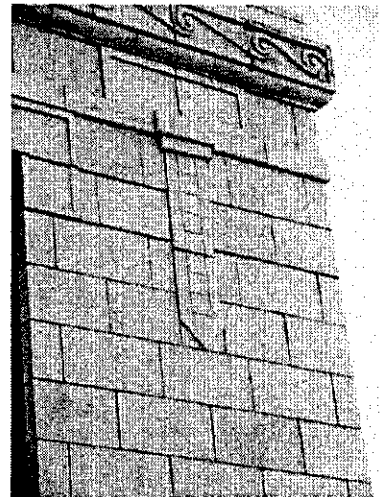
Ornamental terra cotta elements such as these urns (left) are in good condition, but need some cleaning. At the building base (right) some masonry elements are displaying signs of movement. (ARCHITEXAS)

Repair cracks caused by structural movement or thermal cycling with flexible sealant to allow future movement without damage to mortar or terra cotta units.

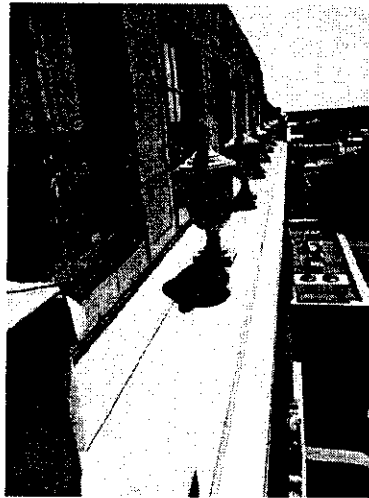
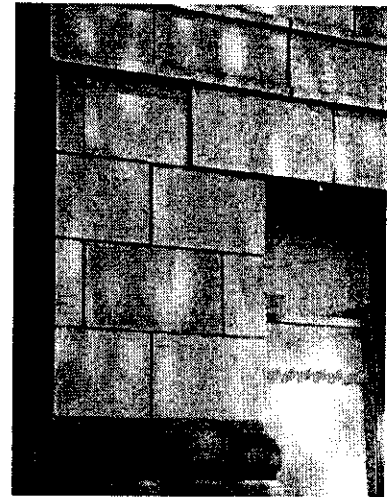
Deep staining of much of the terra cotta will require some experimentation to determine the most effective cleaning methods. (ARCHITEXAS)

There is staining on the terra cotta that is most noticeable at the entry porticoes on the columns and headers.

Remove stains using a preservation cleaner designed for that purpose. Severely embedded stains may require experimentation with long-term treatments. At no time should the building be sandblasted.

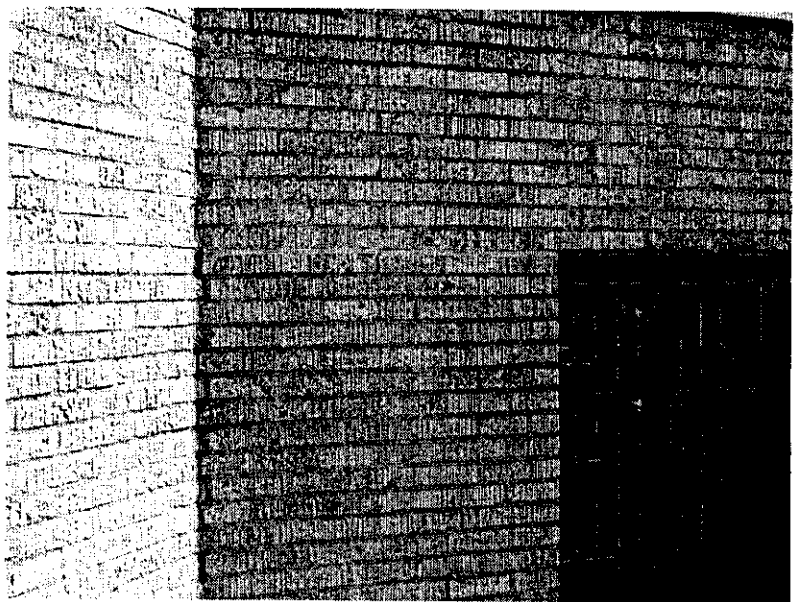
Existing sealants are beginning to fail and require replacement. Brick is in good condition. (ARCHITEXAS)

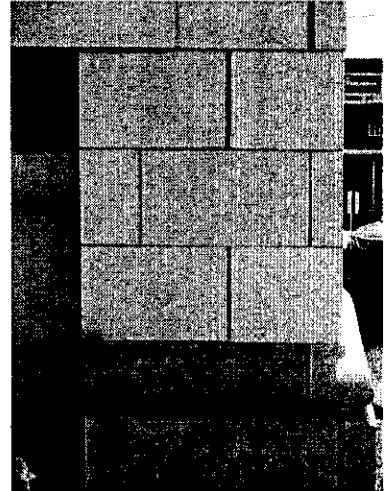
Good. Only minor wear and tear of the stone was noted, although some mortar joints are moderately weathered.

Stone at the base of the building exhibits some movement and surface erosion. (ARCHITEXAS)

Rout and spot-repoint mortar joints as necessary with mortar to match the original in color, compressive strength, and joint profile.

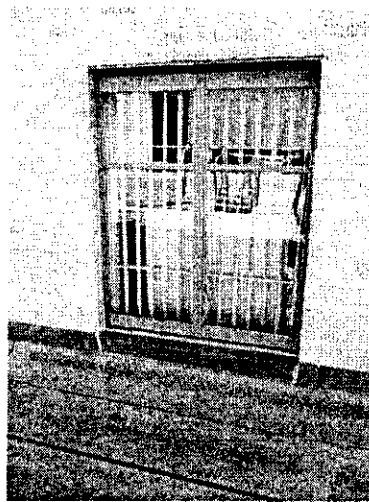
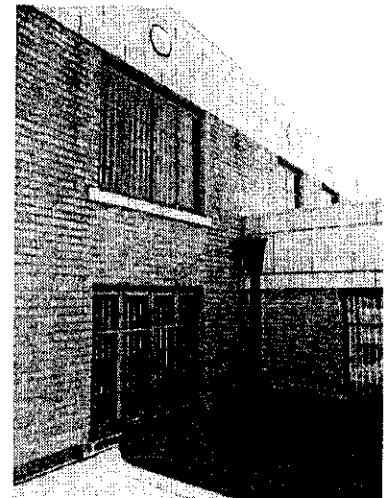
The steel butterfly casements are generally in good condition but are in need of a comprehensive rehabilitation. (ARCHITEXAS)

Partial restoration could include the stripping and repainting of windows in place, replacement of perimeter sealants, replacement of broken and non-matching glass, and replacement of glazing compound. This would not necessarily return the windows to operable condition, and those windows that have been heavily modified would probably need to be removed for restoration in the shop.

If full restoration to original, operable condition is required, a detailed window-by-window analysis should be performed to determine the extent of deterioration and the number of missing components. Full restoration will probably dictate that many of the window sashes be removed for shop restoration, particularly those windows that have been heavily modified.

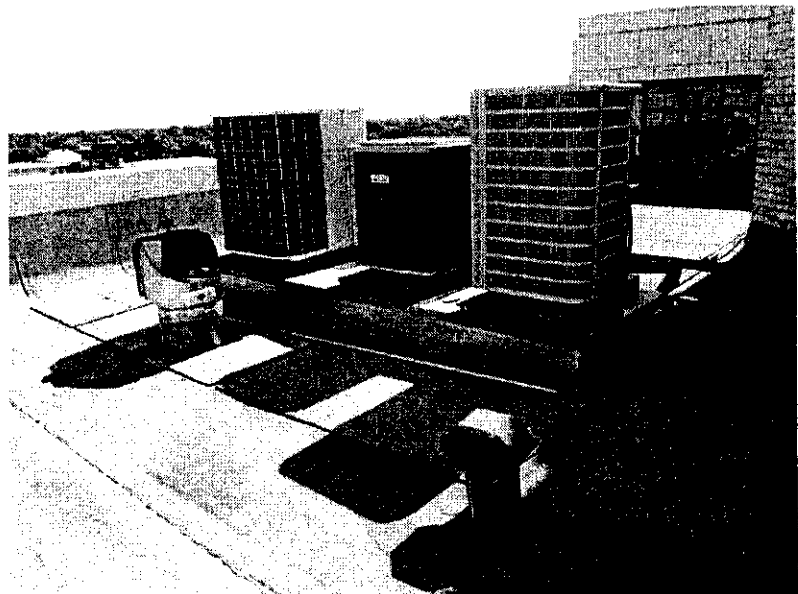
Typical equipment pads on the roof. (ARCHITEXAS)

lar surfaced modified bitumen membrane to prevent ultraviolet deterioration. Add walkway pads as required for access. Place air conditioning units on appropriate supports designed for selected roofing system.

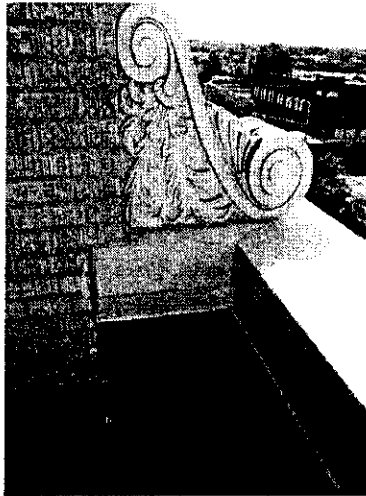
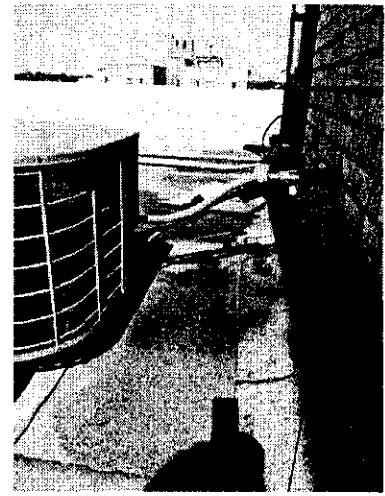
*Typical parapet flashings (left).
Ponding near the elevator penthouse
(right). (ARCHITEXAS)*

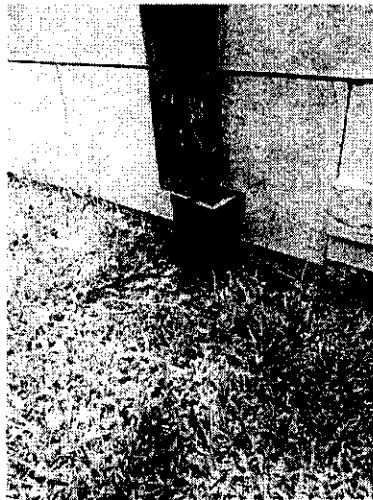
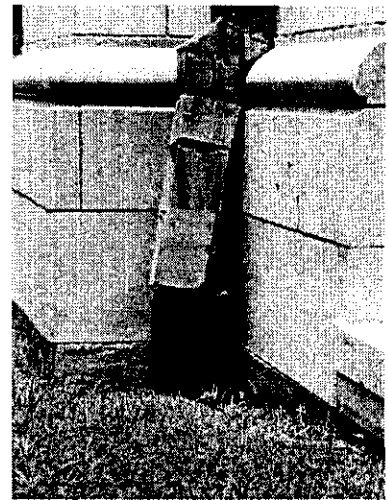
Settlement of the soils on the site has left the roof drainage system disjointed and ineffective. (ARCHITEXAS)

Scuppers, collector boxes and downspouts require refurbishment. (ARCHITEXAS)

Existing Conditions:
Fair. Slope appears to be sufficient. Roof drain size appears to be sufficient for at least a 10 year storm. Roof drain baskets are either missing or broken. There are no overflow drains. Lower portions of downspouts are in poor condition and storm drain tie-ins are displaced and disconnected.

Recommendations:
Evaluate roof slope and add crickets between roof drains at the time the roofing system is replaced if necessary. Either replace the roof drain fittings (if required) or replace the strainer baskets at the same time. Consider adding overflow drains or scuppers.

Clean and repair all copper downspouts and scuppers. Repair underground drains and connections.

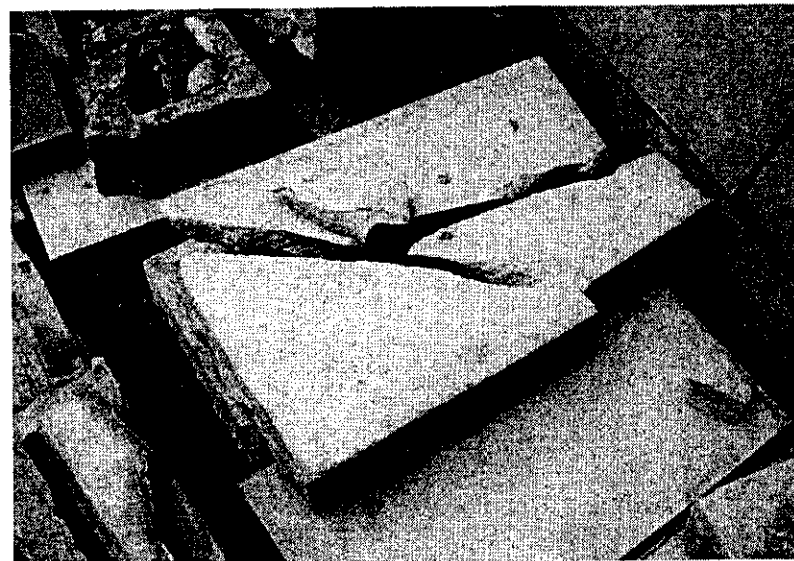
crete has rendered the monumental staircases unsafe and unusable. Terra cotta has suffered extensive damage and has been removed on some sections. The landings of the upper staircases cover basement level entries. These landings now require shoring to prevent collapse.

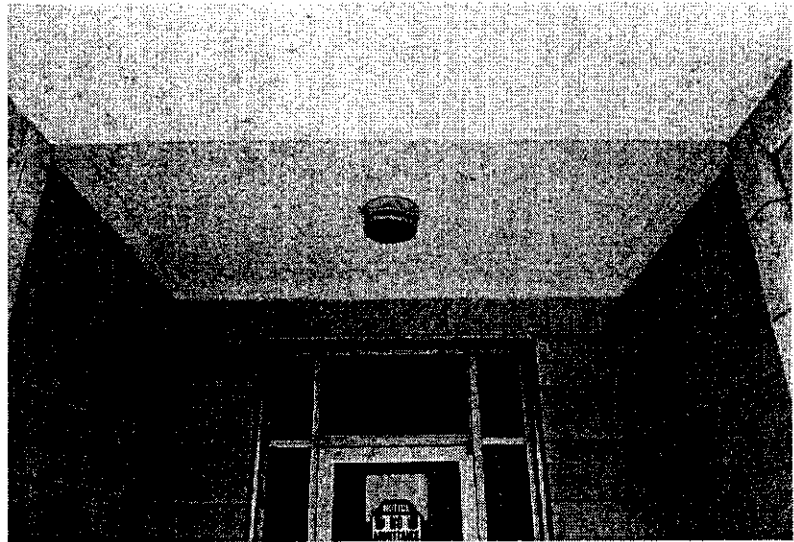
Plaster soffits at the east and west entries are in good condition.. (ARCHITEXAS)

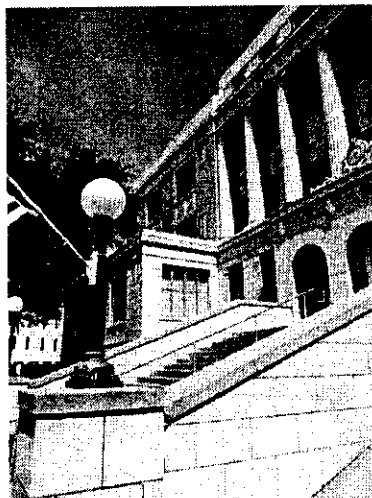
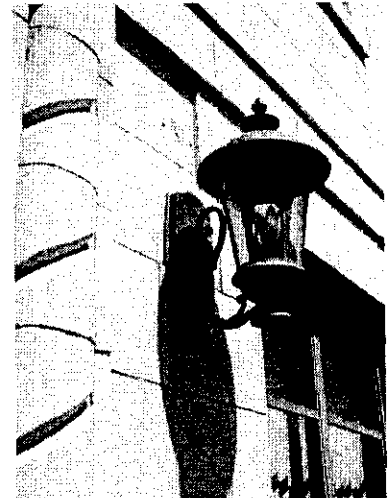
(4) Attached Lighting 3

Fair. The luminaries are missing the decorative bashing that once covered the globes (visible in historic photos). The sconces are not original and, while fairly compatible, resulted in additional damage to the stone due to a new mounting location.

Luminaries on the step checks are original but are missing some parts. The sconces at the side entries are not historic. Mounting locations for the original fixtures are clearly visible on the walls above them.. (ARCHITEXAS)

Restore historic luminaires. Rewire with contemporary lamping and repaint based on the findings of a paint analysis. At the east and west, provide new sconces to match the original.

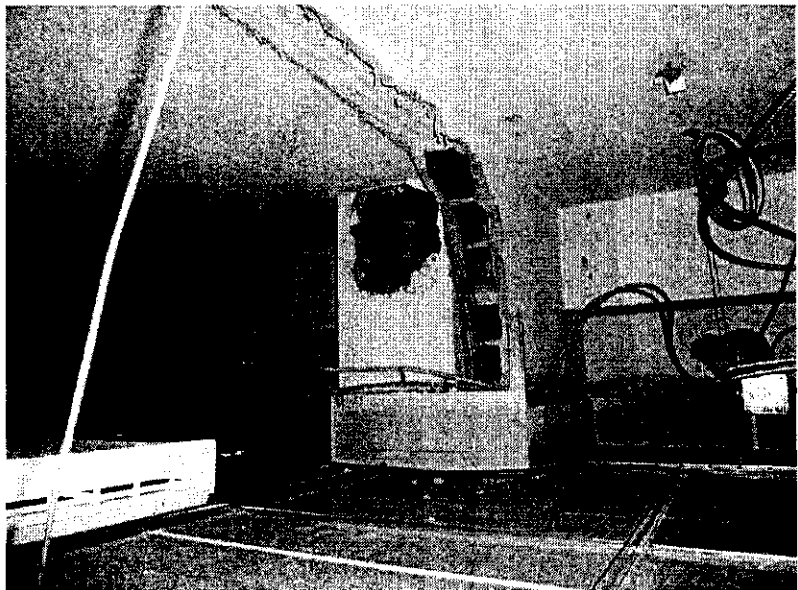
Good to fair Several areas throughout the building are moderately deteriorated due mainly to water infiltration and general wear and tear. The deterioration is not widespread. Typical deterioration problems include stains, minor cracking, minor spalling, and rough surface texture from wear and previous patching, damage from surface-mounted utilities. In general, walls throughout the building are in good condition, but some extensive sections of walls have been removed, particularly on the second floor in the area now serving the 354th District Courts.

There is limited deterioration of the wall and ornamental plaster above the suspended ceiling in the district courtroom. The condition of the plaster in the enclosed balcony is unknown..

A view of typical conditions above a suspended ceiling in a modified area. (Architexas)

Remove any loose and delaminating plaster to sound substrate. Correct any underlying problem, such as water infiltration or other symptom, which is causing damage to the system. Fill holes or other wear related problems. Repair with new plaster to match. Repaint to match original color.

A similar approach should be taken in the district courtroom. Overlying materials should be removed and resulting damage repaired as above. Reconstruct plaster ornamentation to match original.

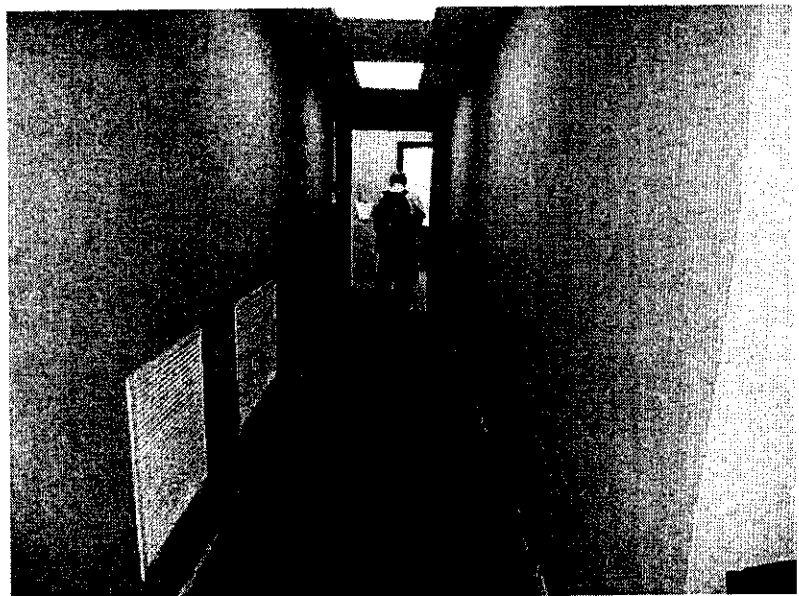
Good. Not original to building. Miscellaneous wear is evident. In most cases, partitions are installed in incompatible locations and configurations and in a manner which is not in keeping with the historic design. Partitions in the jail are not well configured.

Gyp wall surfaces within an existing historic passage on the third floor. (Architexas)

Remove walls which are not original to building wherever possible. Patch holes and repaint to match original color.

Where new walls are constructed in new or historic locations, they should be compatible with the building. Reconstructed walls should match the historic in visible detail. Entirely new walls should be differentiated as new but in a manner compatible with the original. This may be achieved with minor changes in moulding profiles of trim, texture or other finishes.

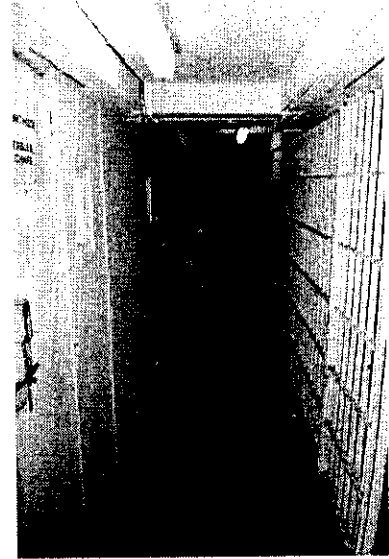
The jail contains a system of steel partitions of bars and plate steel forming cells and inmate facilities. Generally used as storage with some poorly configured offices for maintenance and Homeland Security.

Good and generally intact but some steel walls have been removed, most notably in the section built across two floor levels. The structure is not designed to support storage of records.

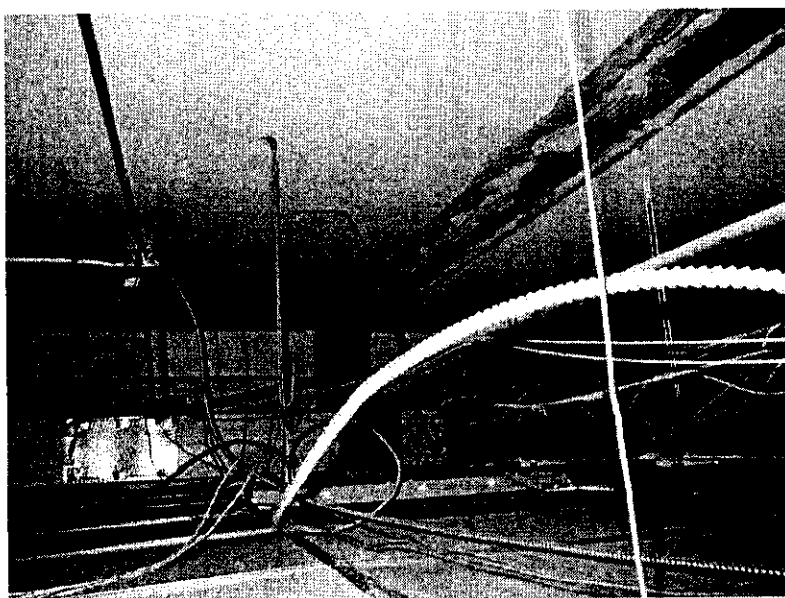
Fair. Ceiling conditions are quite variable. Many ceilings show no signs of distress, while others have minor water staining or minimal cracking.

Moisture damage is evident around the perimeter of the 196th courtroom ceiling. Almost all ceilings outside of the corridors are concealed by 2x4 grid ceilings.

A view of typical historic ceiling conditions above a suspended ceiling in a modified area. (Architexas)

Conduct repairs as necessary and repaint to match original color and finish. Eliminate grid ceilings in favor of fully integrated systems.

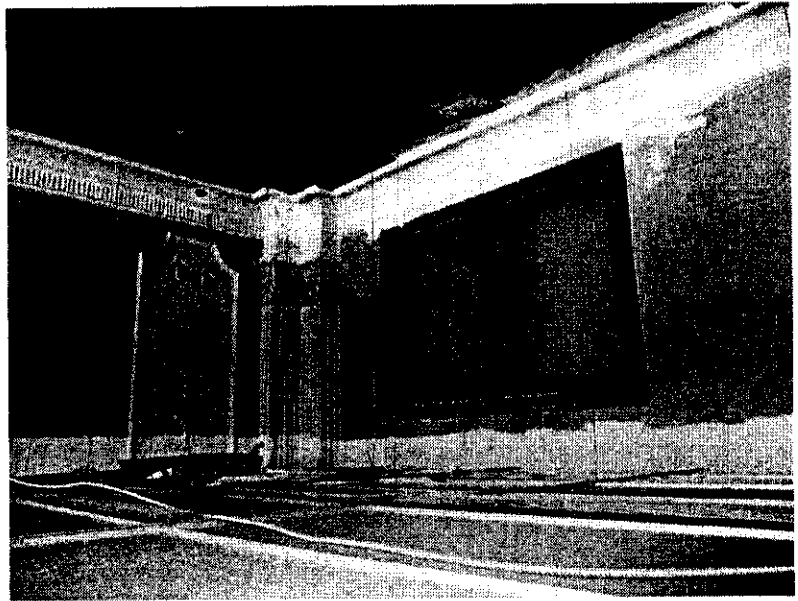
Finishes above the suspended ceiling in the 196th District Courtroom are original. (Architexas)

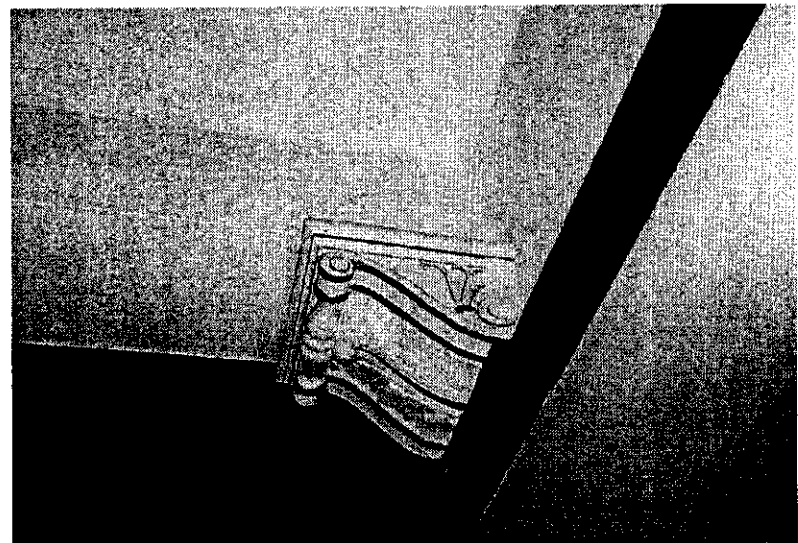
Ornamental plaster in the corridors is fairly simple. Paint finishes are not original. (Architexas)

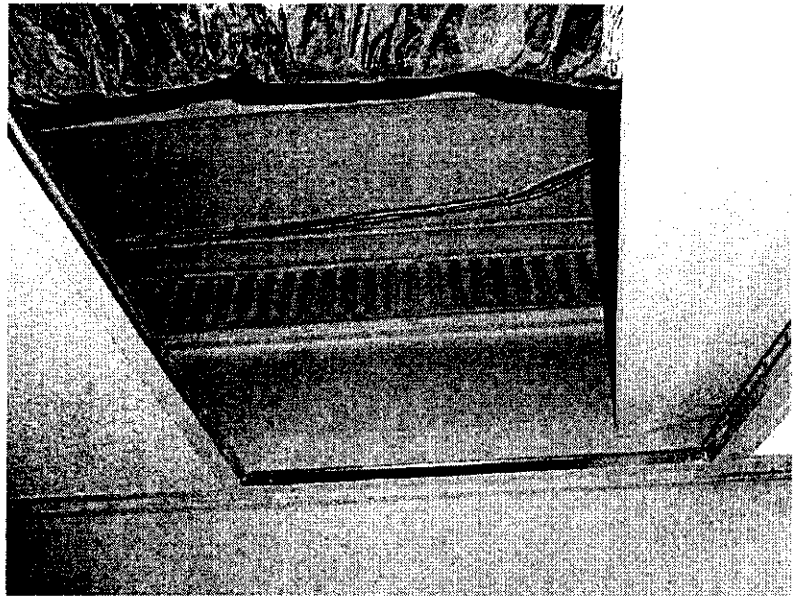
Fair. In general, the plaster ornamentation remains intact with the exception of water-damaged portions of the district courtroom ceiling.

Ornamental plaster hidden in the converted 196th courtroom balcony. (Architexas)

Conduct repairs to existing ornamentation as necessary. Reconstruct any ornamentation destroyed in past renovations.

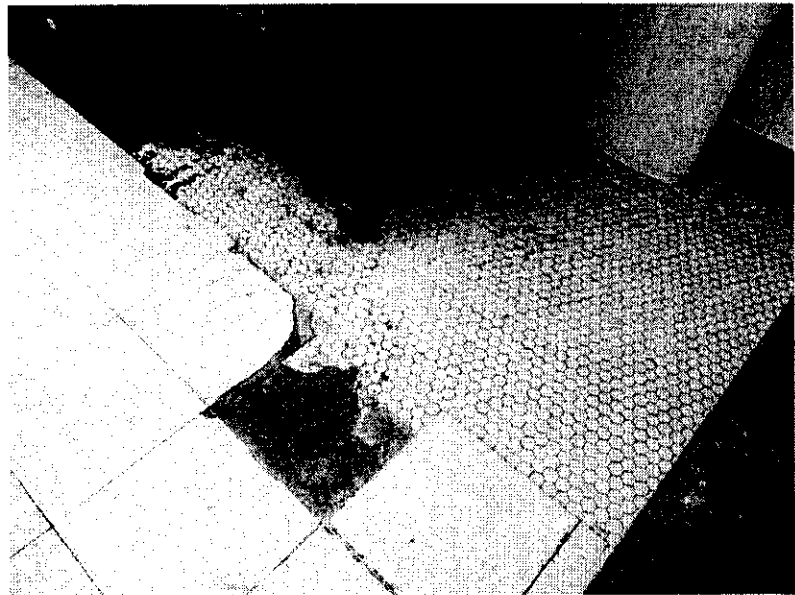
Hex tile floors in old restroom areas will require extensive rehabilitation. (Architexas)

Varies. In some historic restrooms it has been partially removed or replaced.

when the courthouse is fully rehabilitated, repair and reconstruct the original hex tile flooring.

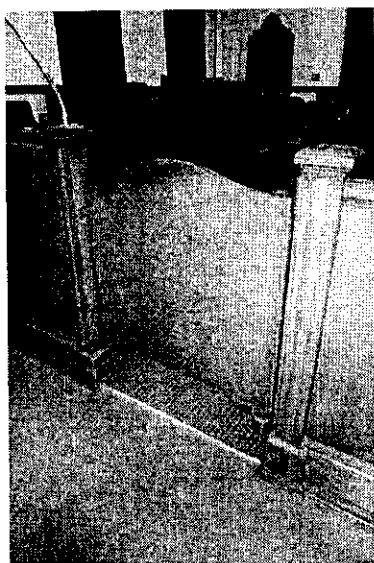
*Historic millwork in the building is generally in good condition.
(Architexas)*

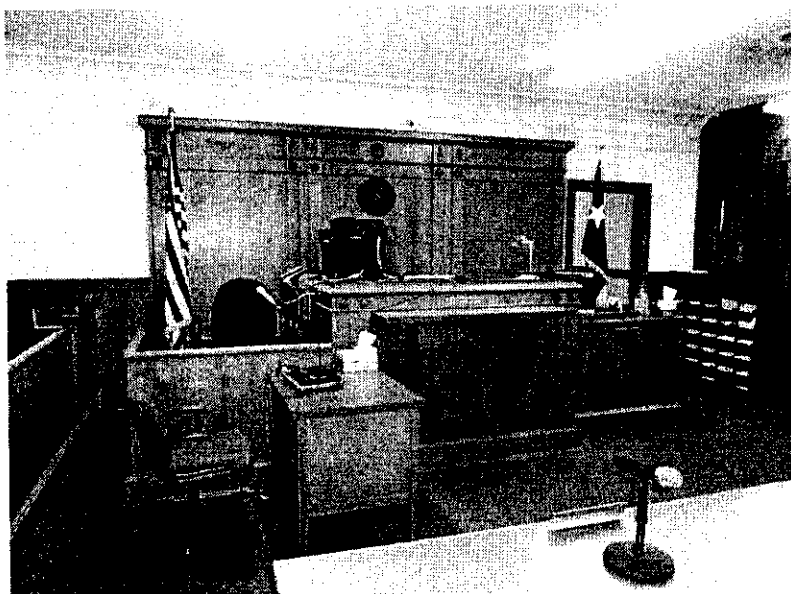
*Built-in furnishings in both historic district courtrooms is intact.
(Architexas)*

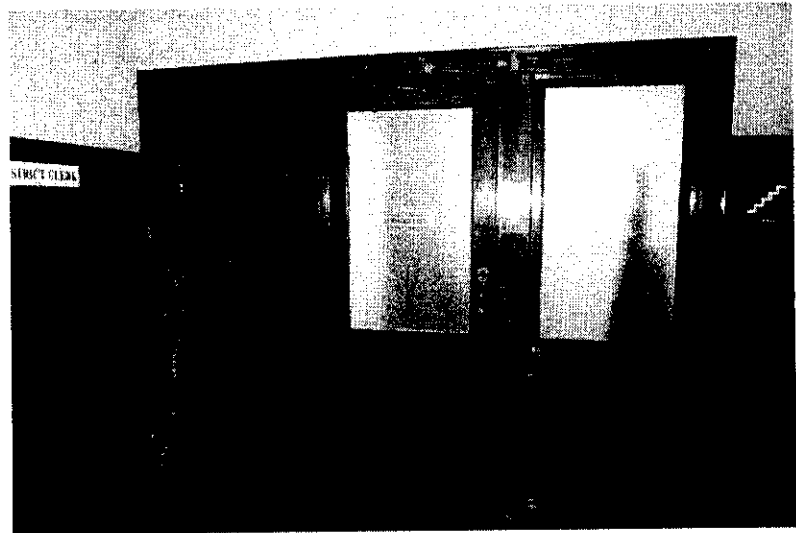
*Typical interior door and sidelights.
(Architexas)*

Good. Most wood retains its original finish and is suffering from basic wear and tear and from the installation of new locks and other supplementary hardware. About 30% of the picture rails above suspended ceilings is missing or has been painted.

Patch miscellaneous holes and repair surface damage.

Remove all incompatible modern trim. Where non-original partitions and wall openings must be retained, replace trim with compatible materials.

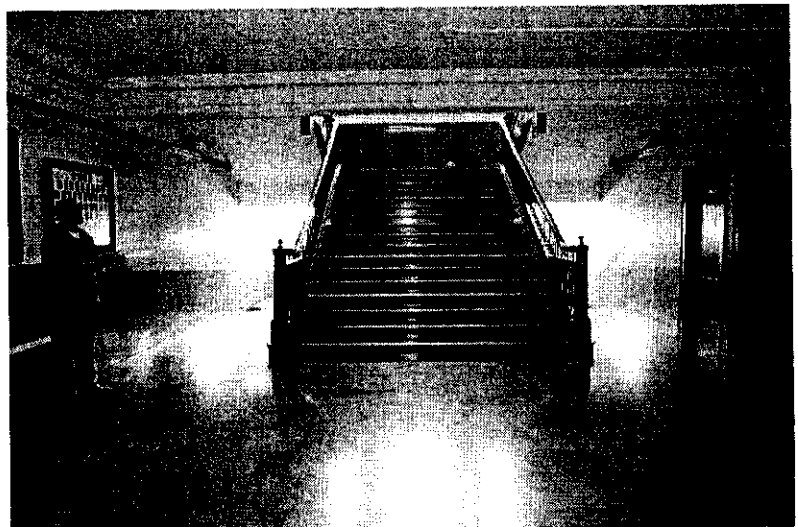
Good. All of the stairs are in good condition with general wear and tear. There is one broken tread on the main staircase. Many of the wood finials at the newel posts are not original and some of the wood handrails at secondary stairs are missing end caps.

A view of the grand staircase at the second floor. (Architexas)

Clean and repaint metal components where necessary. Clean and polish marble. General maintenance. Reconstruct all missing com-

ponents. Extend the second fire stair to service all floors of the building.

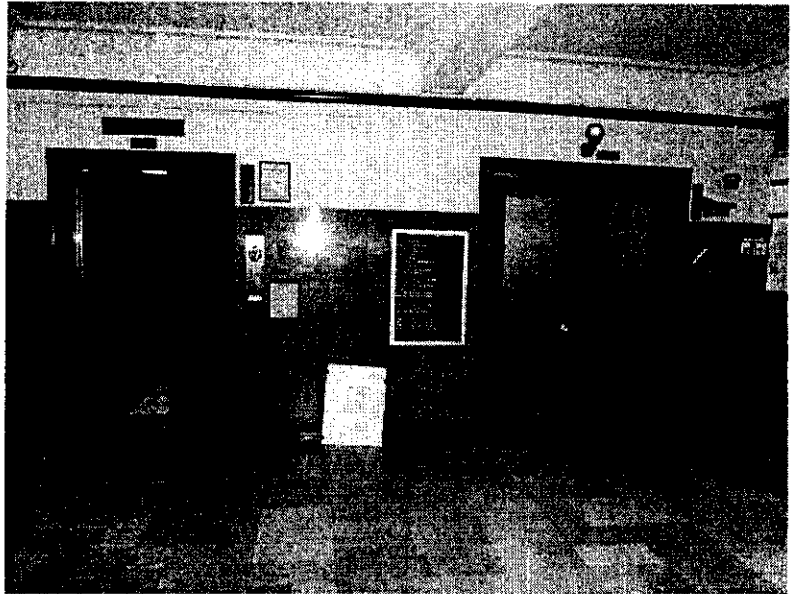
The elevators are in fair condition but are not in compliance with code

An original elevator (left) and fire stair (right) on the ground floor. Gray painted metal elements were probably originally painted to look like oak. (Architexas)

requirements. Elevators require two-way communication, hoistway ventilation, a self closing and locking door, and pit ladders, pit lights or receptacles.

Conduct repairs and improvements to hoistway, pit and machine room as required by state regulations.

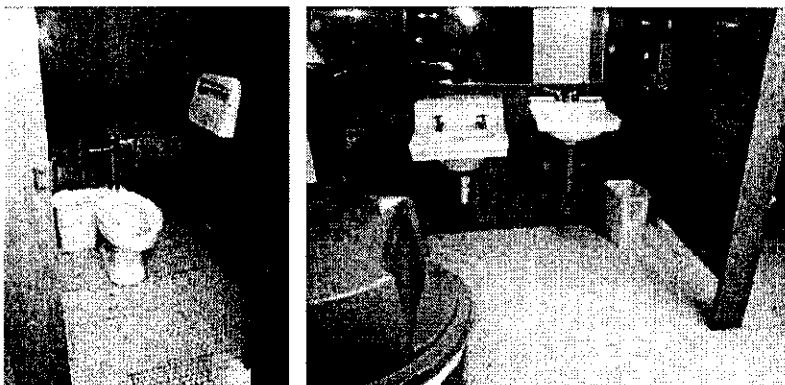
Typical restroom fixtures. (Johnson Consulting Engineers)

Fair. Plumbing fixtures are in working condition.

Replace all fixtures and piping with any architectural renovations.

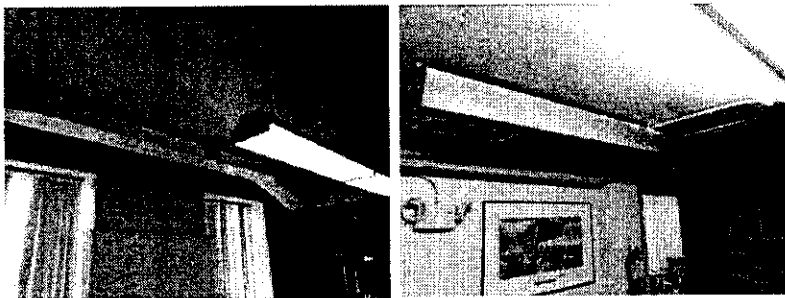
Typical examples of exposed ductwork. (Johnson Consulting Engineers)

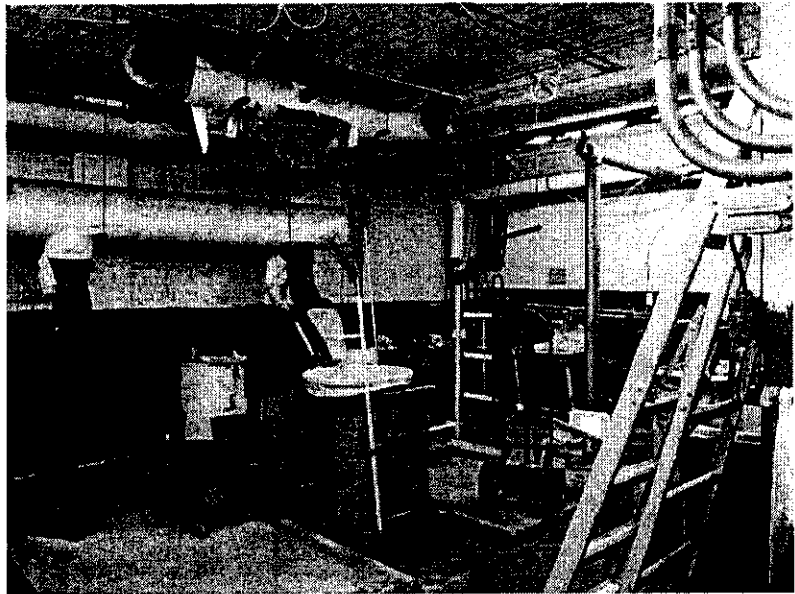
Steam piping in the boiler room. (Johnson Consulting Engineers)

the end of its useful life. Equipment replacement occurs on an as needed basis. While the systems are operational based on the current building occupancy, it is unlikely that the existing system, and especially ductwork, could remain intact during a complete restoration. In addition, the lack of introduction of outside air can lead to sick building issues and should be addressed.

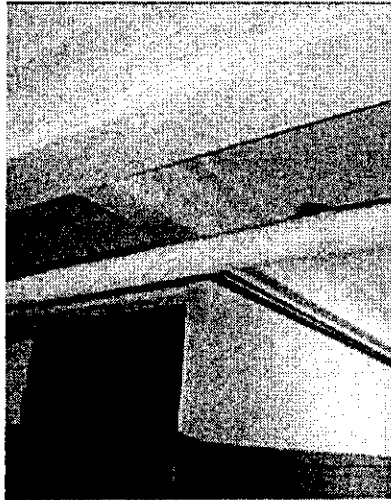
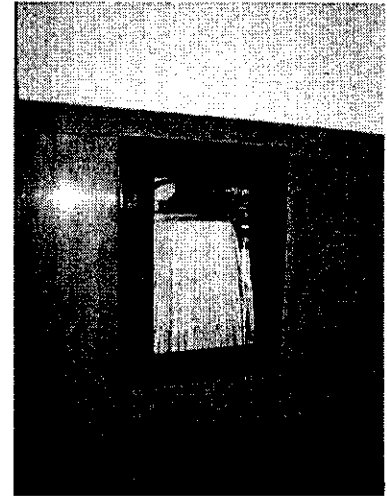
*Fire standpipe and hose cabinet.
(Johnson Consulting Engineers)*

Install a new complete fire sprinkler system in accordance with current building code requirements and NFPA standards.

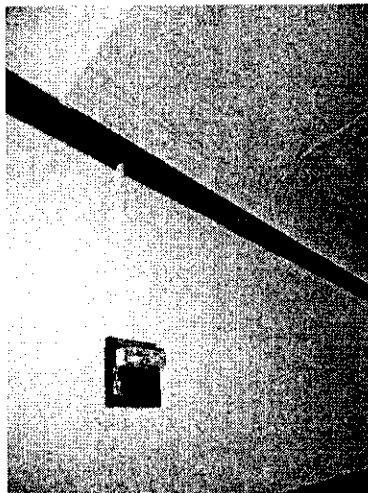
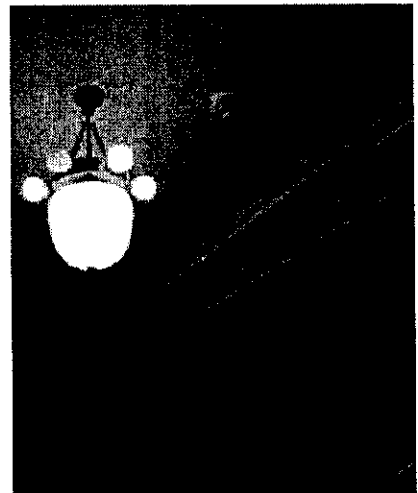
Fair. Existing system is approximately 10 years old.

*Typical fire alarm and detection
system components and raceways.
(Johnson Consulting Engineers)*

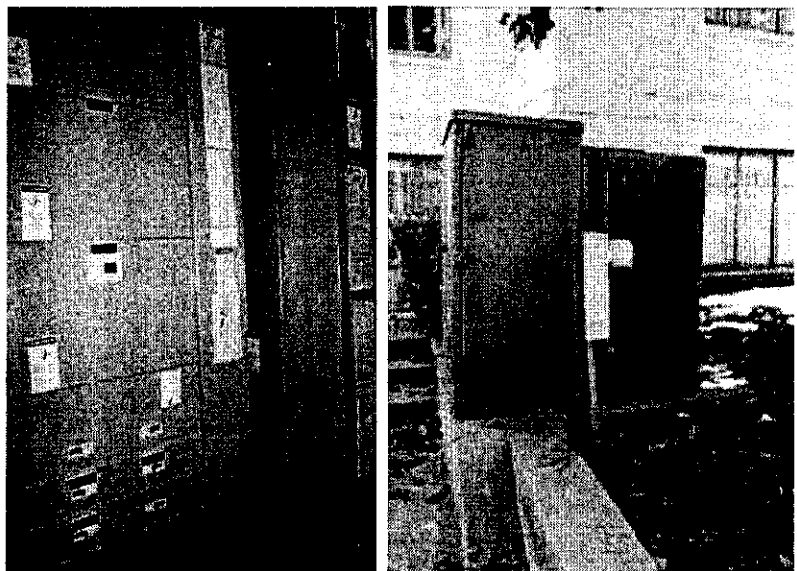
Some surface mounted conduit and receptacle boxes were noted.

Instances of separated exterior conduit were observed.

Electrical service and pad-mounted transformer. (Johnson Consulting Engineers)

Very Good.

The existing electric service is of adequate capacity and in good condition. The only revisions necessary are those related to architectural updates - for example as walls are moved, new receptacles will need to be installed. Additionally, the surface mounted panelboards should be relocated to electrical rooms or closets and the conduit and outlet boxes should be embedded in the walls that remain. Consider relocating transformer to less prominent location on site. Repair separated conduit.

(ARCHITEXAS recommends the relocation of the existing exterior transformer. The transformer ideally should be placed off site. If such a relocation is not feasible, it should be moved to a location farther removed from the building and screened with landscaping.)

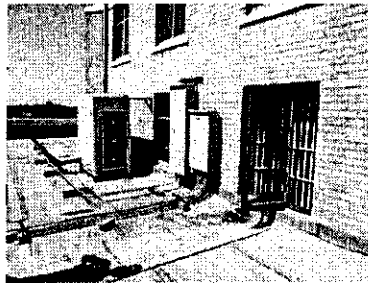
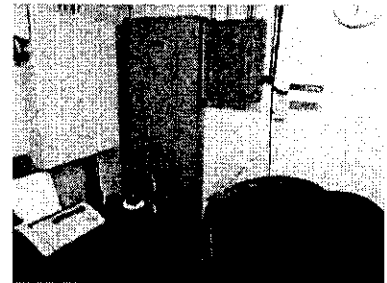
*Rooftop and office sub-panels.
(Johnson Consulting Engineers)*

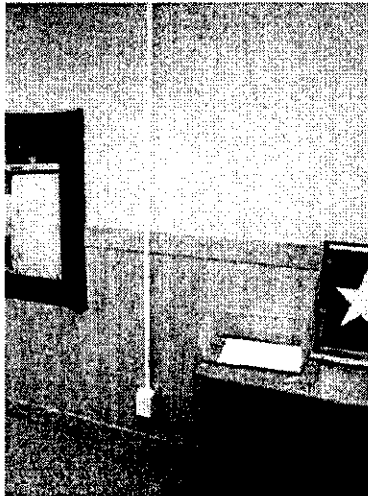
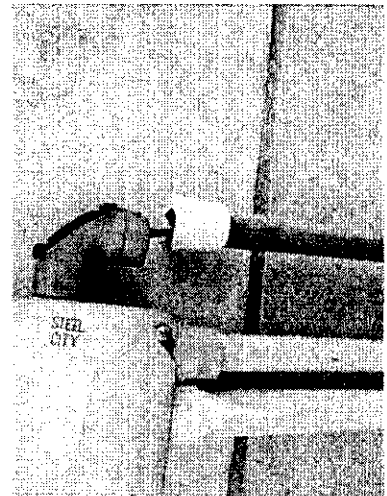
*Interior and exterior surface-mounted
conduits. (Johnson Consulting
Engineers)*

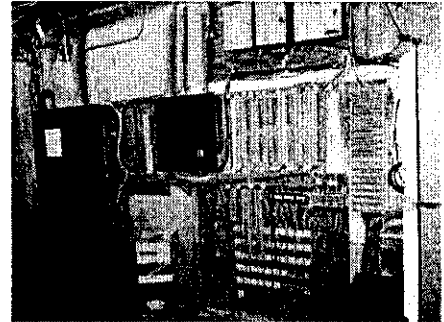
Main telephone panel. (Johnson Consulting Engineers)

The telephone and data distribution system should be centralized in a new telephone/data closet dedicated to that use and new wiring that is appropriate for current standards should be installed.

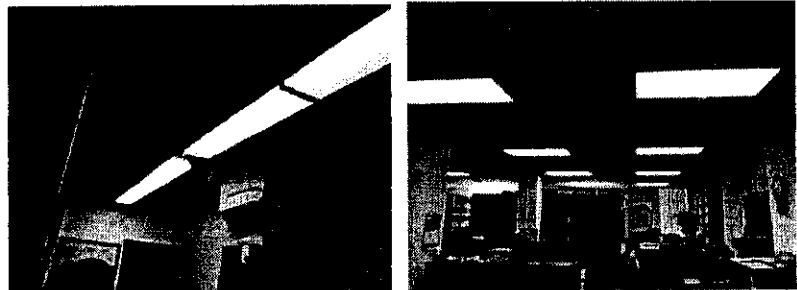
Typical lighting fixtures. (Johnson Consulting Engineers)

Fluorescent fixtures in the office and courtrooms should be replaced with fixtures that reflect the historical nature of the building. As historic ceilings are exposed, recessed LED downlights should be installed for general lighting along with historically authentic fixtures compatible with the restoration.

(ARCHITEXAS note: Original lighting fixtures and globes still exist in a few locations and should provide adequate evidence for replacement/reconstruction of the historic fixtures.)

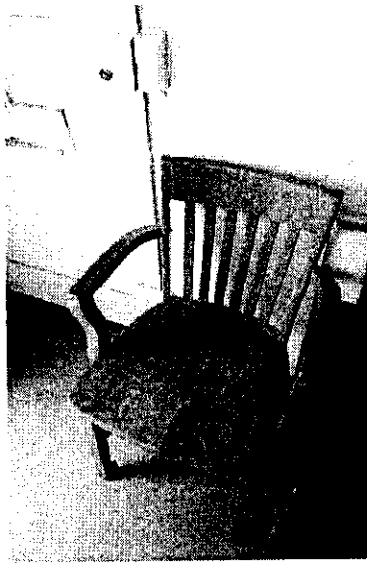
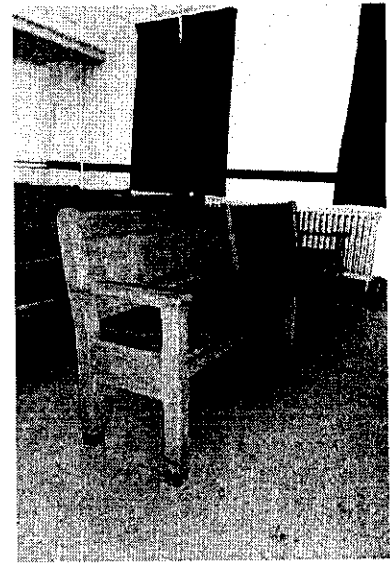
Examples of historic, movable furnishings are located throughout the building. (Architexas)

Good. In general, the original furnishings are in very good condition. Some doors, and drawers do not operate freely and some furnishings have missing hardware and are not entirely stable.

Conduct a full inventory of all original courthouse furniture across all county facilities and return any displaced items to courthouse. Restore furnishings to original condition. Clean, refinish as necessary and provide new hardware as needed to match original. Repair damaged elements and re-secure loose fasteners and components.

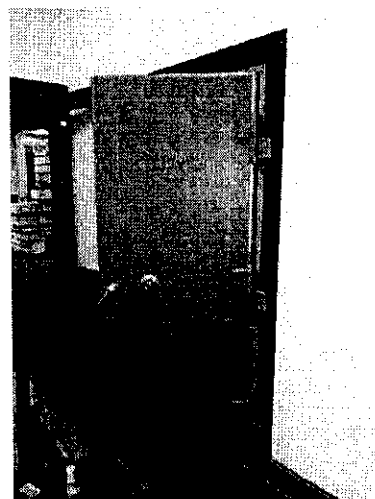
Fair. Many of the building's vault doors have been removed. Three that remain are original to the building. These vaults are generally in good condition. They have been repainted with period-similar paintwork that is not well executed.

Clean vault doors and mechanisms to allow free movement of parts. Properly restore the original paintwork. Have locking mechanisms reset by a locksmith to allow proper operation, or disable the mechanisms to avoid accidental locking of the vaults.

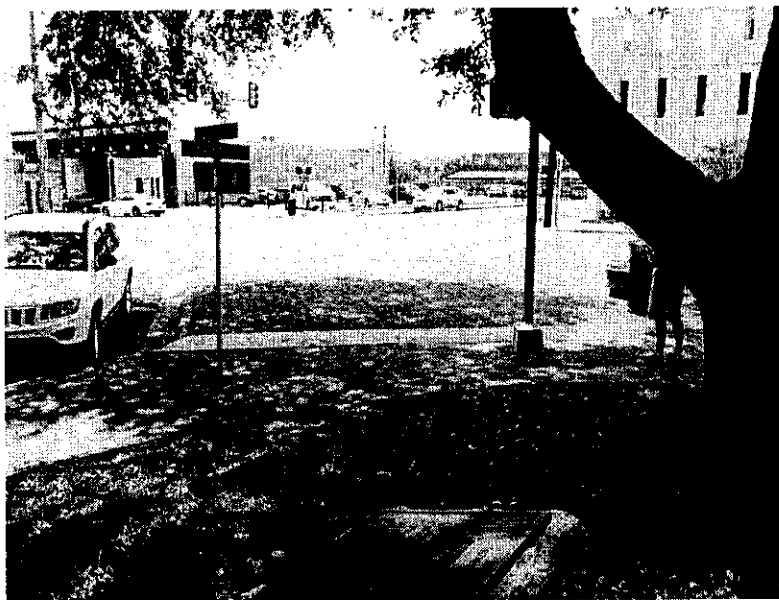
Typical site conditions at the four corners of the square. (Architexas)

Portland cement concrete paving at most locations. Original sidewalk layouts as shown on original site plan remain with a number of repairs and modifications made over the years. The most notable modification is the removal of the streetside curb at the corners of the square and the installation of traffic islands. There are many chips, breaks, spalls and patches in the curbs and sidewalks.

Fair. While much of the sidewalk and curbs are intact, repairs and modifications have left a messy appearance and created uneven surfaces.

In the short term, ensure sidewalks are maintained and trip-hazards repaired. Long term it is recommended that the original paving be carefully documented and the historic site plan restored to its original pattern except where modifications are necessary for code compliance and access. It would be preferred to eliminate the traffic islands at the corner of the square. If these are deemed absolutely necessary, they should be redesigned to better complement the original paving pattern.

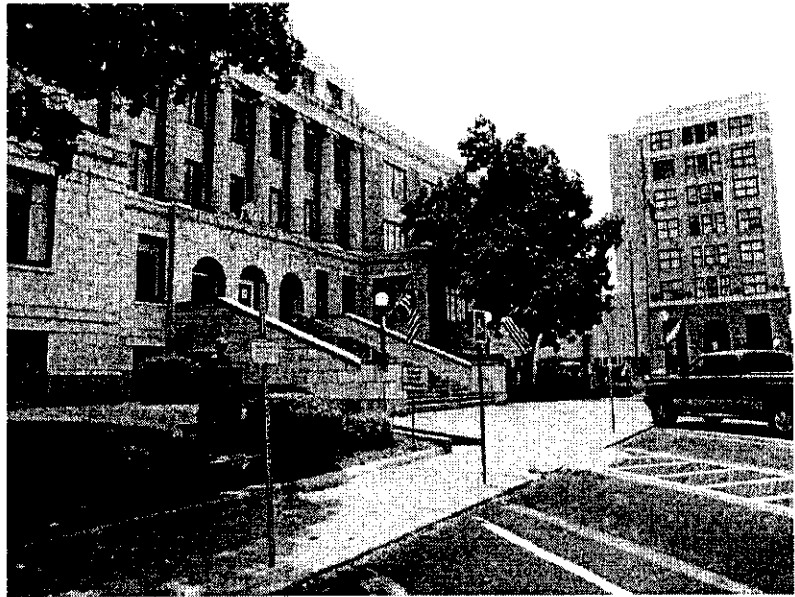
*North site and accessible parking.
(Architexas)*
