**ENROLLMENT FOR ELECTRIC SERVICE
LETTER OF AUTHORIZATION**

WHEREAS, the courthouse is in need of critical repairs;

Scope of Protection Documentation

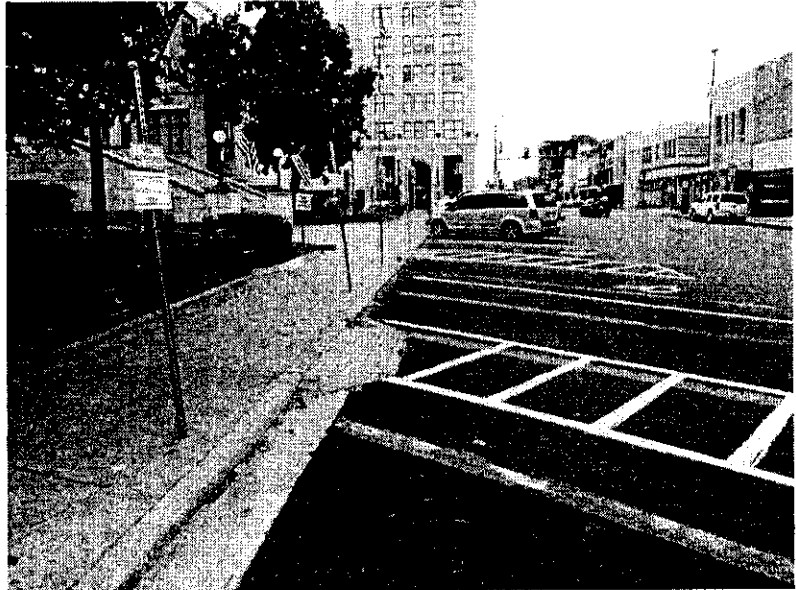
Signs and other graphics clutter the square. (Architexas)

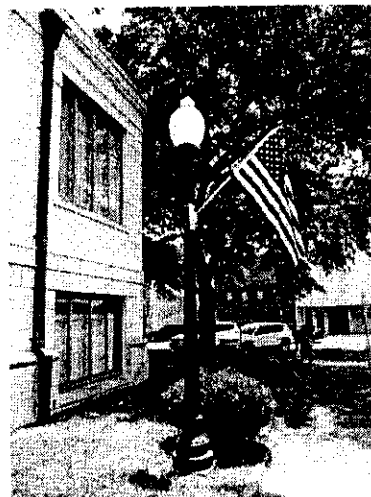
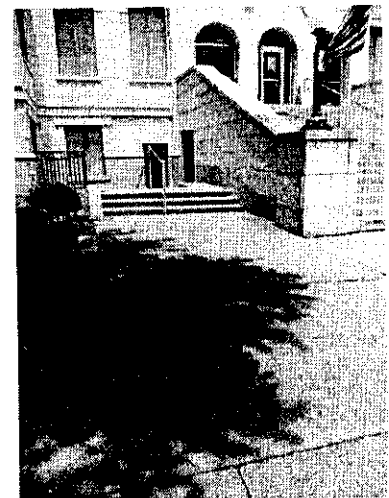
Aluminum flagpole located on the northwest corner of the site. Flag holders have been clamped to all light standards.

A new methodology for mounting flags around the square is recommended (left). A variety of hand-rail types exist and detract from the appearance of the courthouse (right). (Architexas)

The exterior of the courthouse would be greatly enhanced if period-style decorative metal railings were used to replace the current industrial pipe railings.

Clean and repair primary flagpole. Design and implement alternative mounting system for flags at light standards or eliminate.

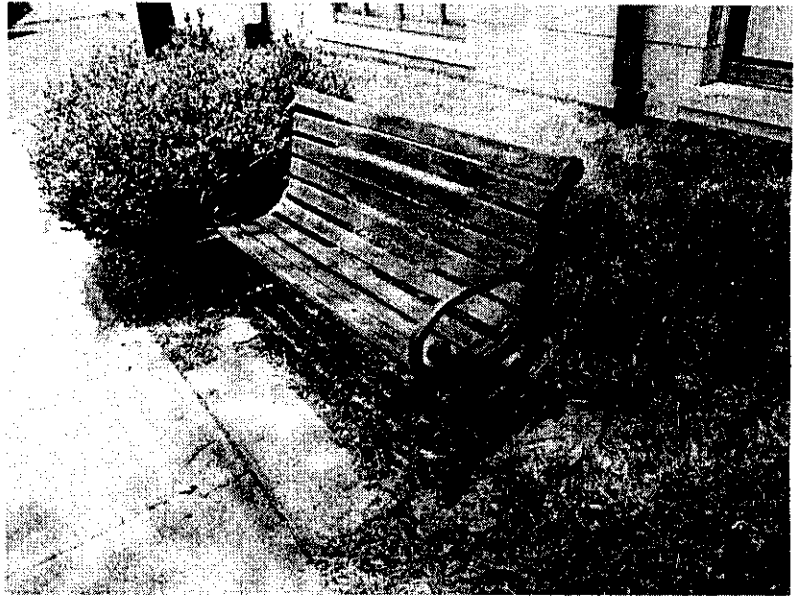
One of several types of benches on the square. (Architexas)

Fair, the benches are deteriorating and do not compliment the square. The trash receptacles are fairly compatible but are in need of repainting and can be better located.
